# FOR ALL GLIDERS WITH UNSHEATHED LINE SETS

Some pilots have noticed a slight disfigurement of their riser lines at the maillon. The issue shown in the photos here does not affect the airworthiness of the glider or the line strength. Please read on for a detailed explanation:

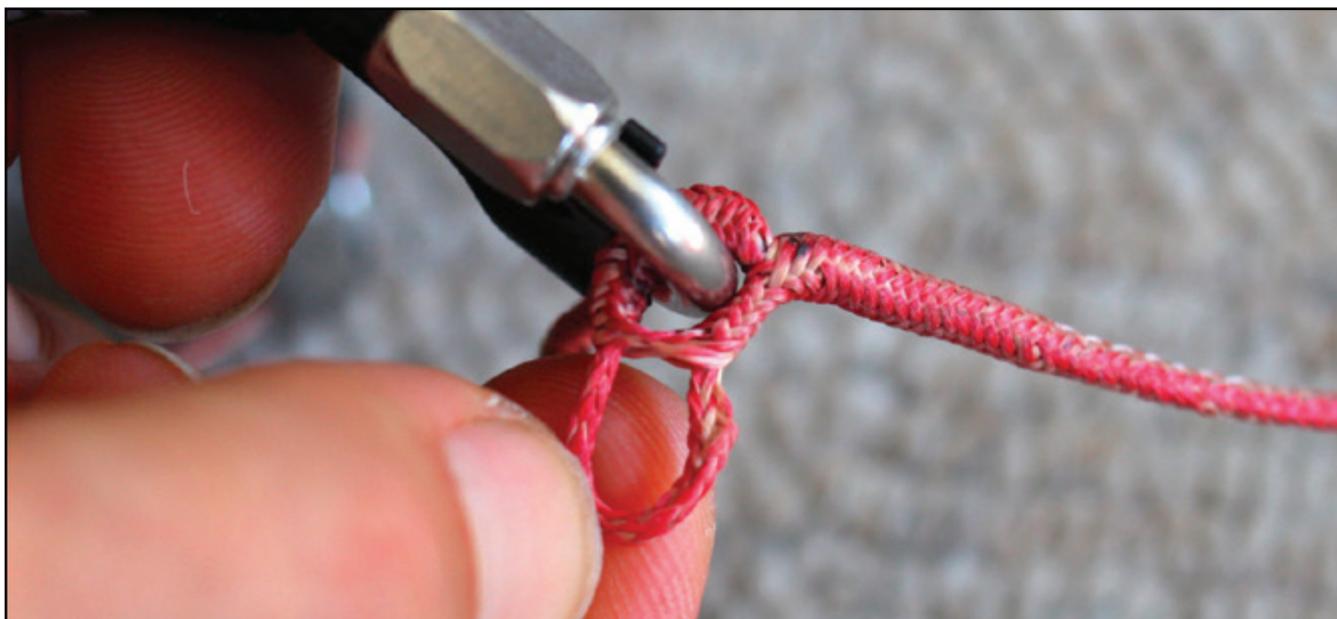
In order to obtain better breaking strengths at line-to-line junctions, we increase the diameter of the lines where they connect to each other by inserting a short section of line at the loop. This segment is only needed at the line to line junction. **It is not needed on the loop which attaches to the maillon.** However, some early production models may have the segments inserted at both ends of the riser lines (this is to simplify production). At the maillon, **there is no strength difference with or without the segment of line inside the loop.** Therefore, if you see this segment working its way out of the loop at the maillon as is shown in the photos, do not be concerned.

Do not compress or deform the maillon loops when launching or ground handling.

1. Don't do anything. You can fly with the loops like they are shown in the photos here, as there is no loss in strength at all. Or, if you don't like the way it looks, then:
2. Pull out the protruding line, **very gently**. Very carefully, work the segment out a few millimeters more on each side. To do this, the main line might need to be compressed lengthwise. Then, using sharp scissors, cut the inside line close to where it exits from the main line. Be very careful during this operation to not pull out or cut any of the main line fiber!

3. If you are at all uncertain, please seek assistance from a certified paraglider check facility.
