Courtesy Safety Notice: AustriAlpin COBRA® buckles

Fulpmes, 14 January 2016

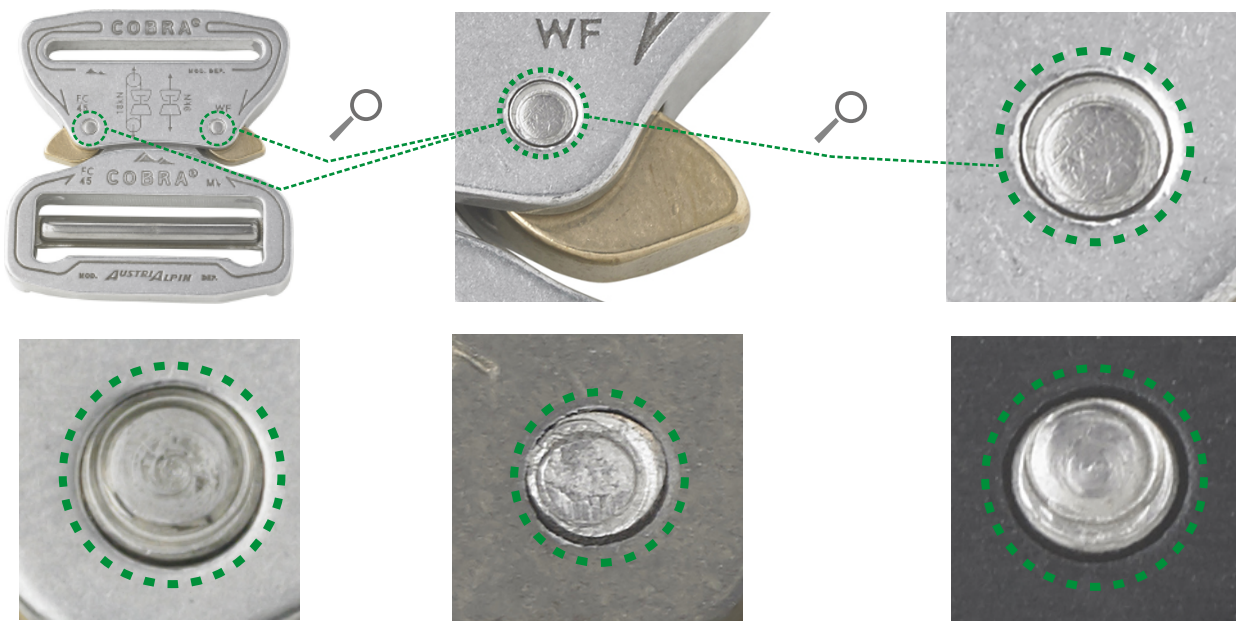
Correct

The rivet shows an embossing in the form of a ring on both the front and back sides of the rivet. Do not manipulate the rivets by mechanical action.

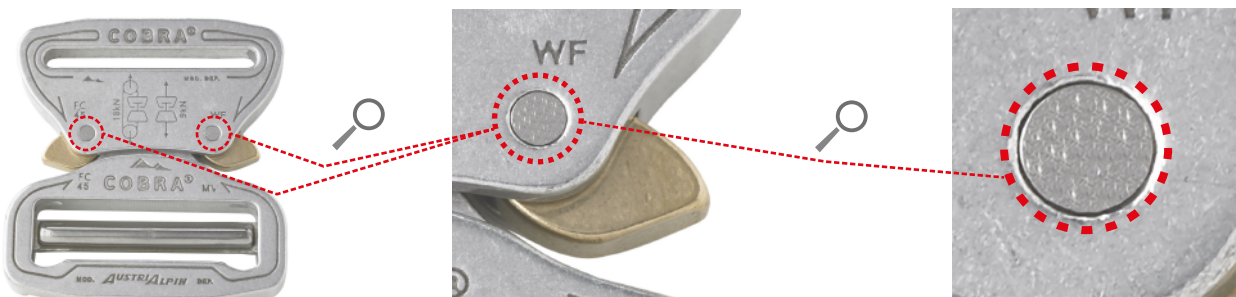
NOT Correct

it has come to our attention that in an extremely small quantity (0.0000005% = 1 out of 2 million) of COBRA® buckles there may exist parts where the rivets have **not** been **press fixed**.

This results in the rivets being loose and the release clips detach. COBRA® buckles in all different versions and sizes can be affected. As we are dedicated to the 100% function, performance, quality and safety of our products, we ask all our clients and end users of COBRA® buckles to **do a visual check**:

The rivet does not show any circular embossing.

If you notice a buckle that is NOT riveted or you do have any concerns, STOP USING the product immediately and get in contact with us: office@austrialpin.at or via phone +43 522 56 52 48
