IMPORTANT SAFETY NOTICE

This notice affects all Exoceed harnesses manufactured before November, 2017.

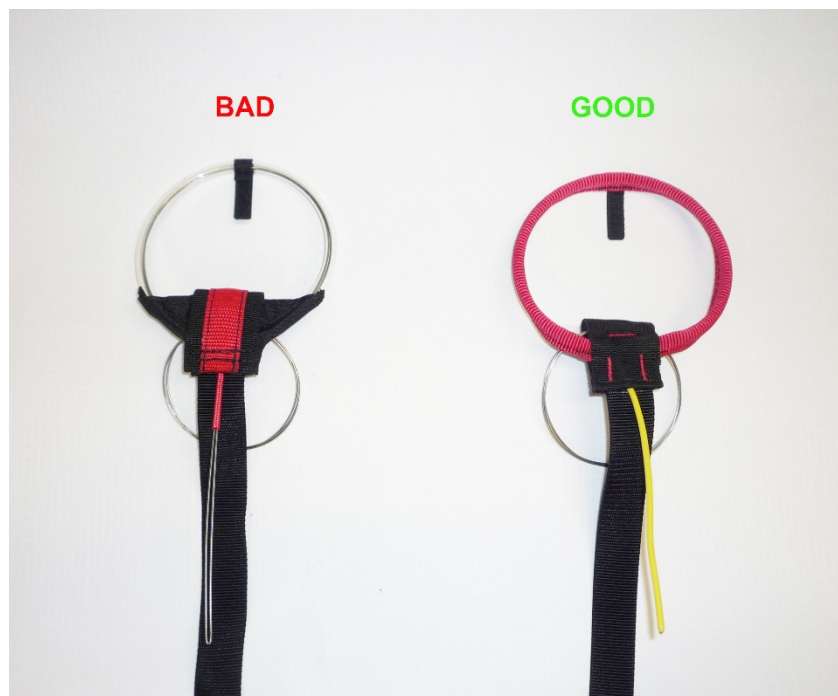
We have been made aware of a potential safety issue with the Exoceed reserve handle. If the metal pin becomes fatigued due to repeated bending while packing the harness, there is a possibility that the handle could break during extraction.

The correct replacement handles are coloured red, if your reserve handles are made from transparent plastic then they must be replaced before your next flight.

Action required: Mandatory replacement of all Exoceed reserve handles.

The reserve deployment handles on all Exoceed harnesses should be replaced before next use. Please contact your dealer to request replacement handles.
